Raymond, SR 101, MP 60.35

Raymond Soil Bioengineering Design 12-28-99

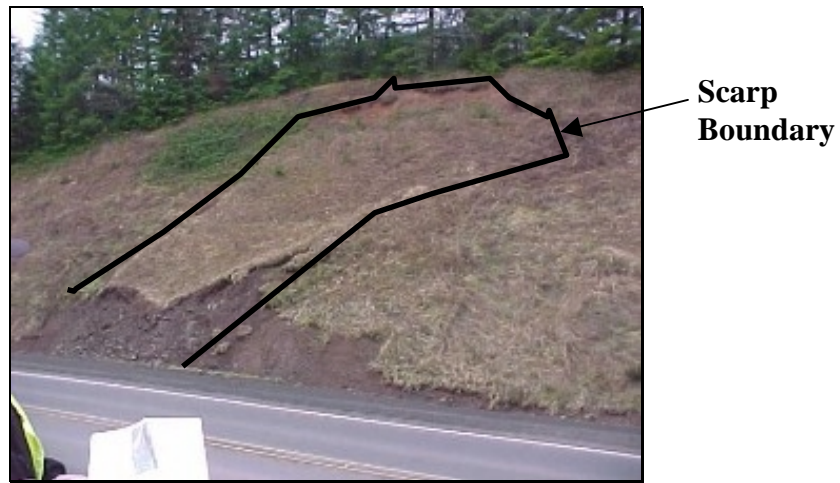
Soils on this 591 feet long by 112 feet high east-facing slope are composed of marine sedimentary rocks that are weathered. Small shallow rapid landslides have occurred where these weathered clay layers have left slope sections exposed to water movement. With excess surface and subsurface moisture, these layers slipped and moved downhill into the ditch. To manage stormwater runoff, maintenance activities required clearing of these plugged ditch lines. In doing so, the base of the shallow rapid landslide was undercut, leaving a portion of the area with an exposed vertical face. During the year, the slope would “adjust,” move again into the ditch line, leaving a larger head scarp exposed to surface and subsurface water movement.

Figure 17. Area of Instability

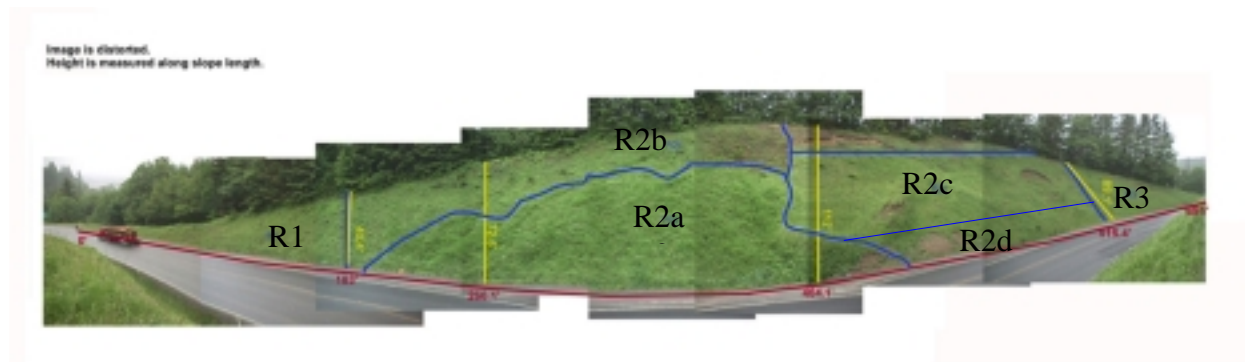
Figure 18. Raymond Research Site with Sub-areas

Area R1 and R3:

Primary focus is aesthetic.

- Plant with recommended mix of vegetation. Install bender board fencing to complement the existing bronze animal sculptures by local artists. Do not excavate a terrace behind the fencing (contrary to usual installation), add fill to create a planting platform. Be sure to mix the added soil with the original slope material.
- Construct cordons

Area R2:

Primary focus is stabilization.

R2a: Plant with approved mix of water-loving vegetation.

R2b: Plant with approved mix of vegetation.

R2c: Soil bioengineering. Starting at 6' above cribwall at slope base:

- Construct a brush layer 5' deep across the slope in the area.
- Construct a willow wall with a brush layer base across the slope above the brush layer.
- Alternate these two treatments at a maximum of 10' intervals up to 75'.
- At 75' above the cribwall, construct willow walls at 10' intervals.
- Goal of these treatments: provide slope stability and easy access to planting areas.

R2d: Construct a live cribwall at the base of the slope.

- 183' to 515.4' = total length of cribwall (as seen from width markings on photo).
- From 260.1' to 515.4' construct cribwall 6'h X 6'w X 255.3'l.
- 77' on either end, construct cribwall 5'h X 5'w.
- 10' on either end, construct cribwall 4'h X 4'w.
- Flange ends to blend in with slope and to eliminate any potential "snagging" safety concerns.

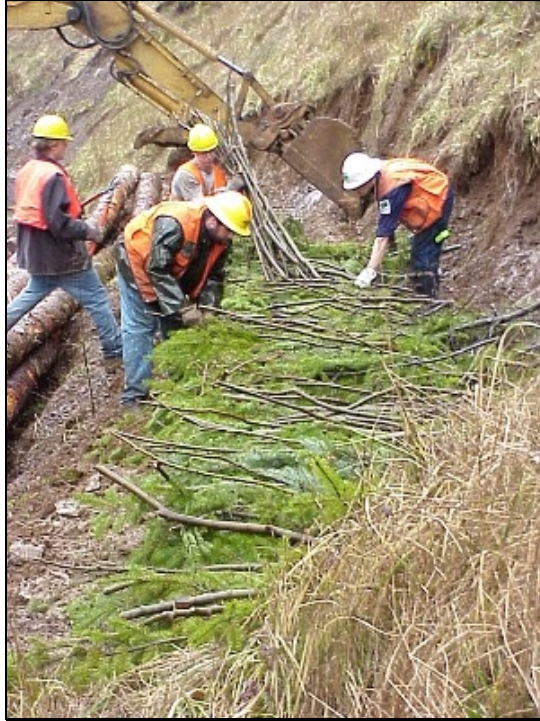
Construction began with region Maintenance personnel using heavy equipment and two WCC crews using hand equipment on February 1, 2000. They began by excavating at the northern end of the site and installing the first cordon. Figure 19 shows the cordon construction after the bottom two logs have been placed in the terrace parallel to the slope.

Figure 19. Cordon Construction

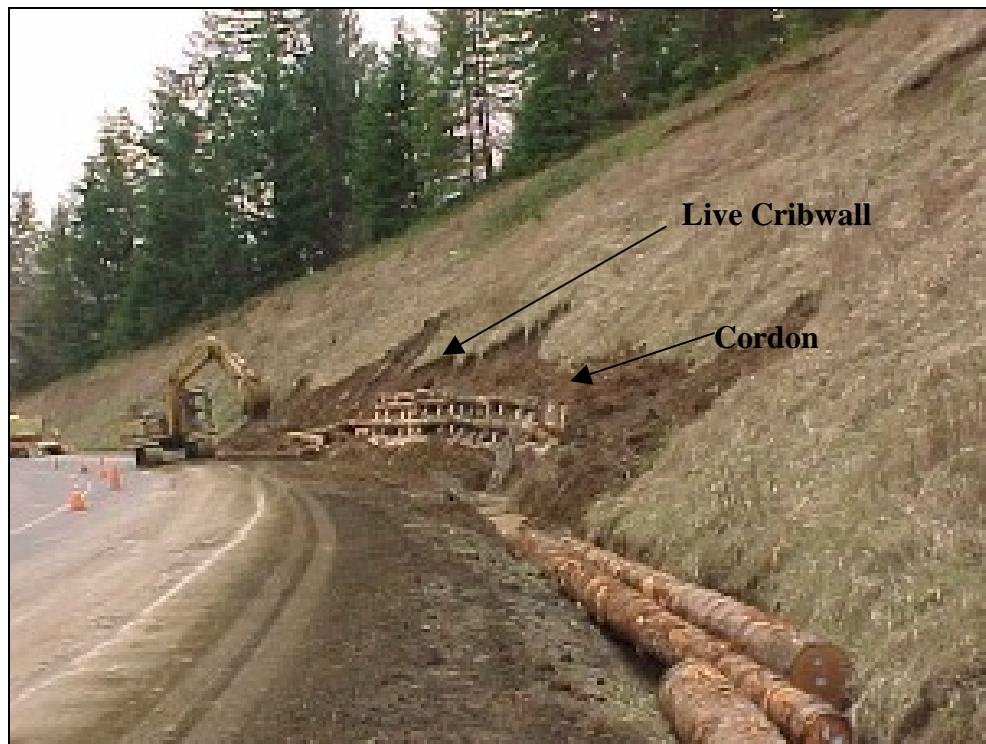
Figure 20 was taken on February 10, 2000. It shows cribwall construction at the end of the first week of construction.

Figure 20. End of first week of construction.

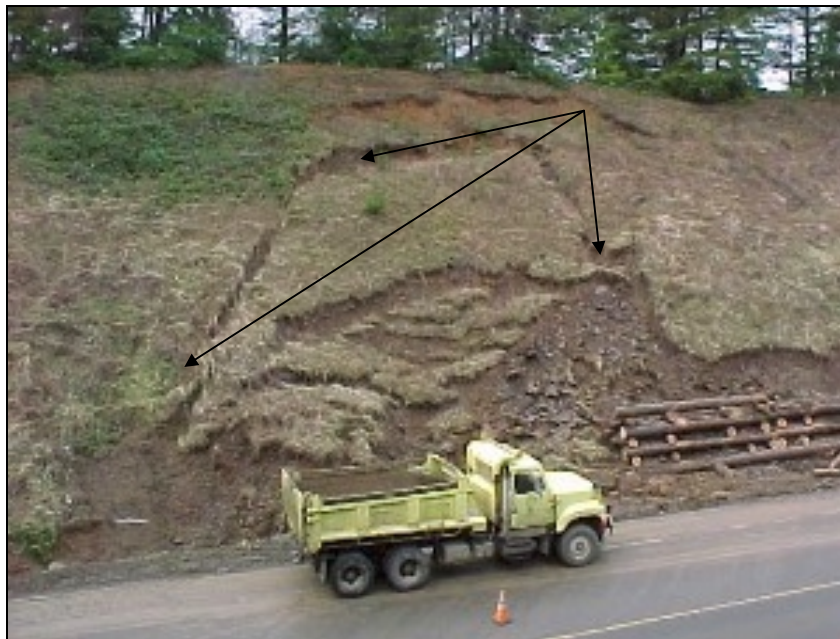
Some excitement here in Raymond this morning. About 80' into the 6X6 section of cribwall, an area approximately 70'W x 90' high began to slide as the excavator was removing the toe. It slid in one piece about 4' vertically in less than 30 seconds. I really hesitate to excavate any more of this area until we have a plan. I instructed the operator to continue to fill in the cribwall that has already been completed (to the right of the slide) as much as possible to counter weight the movement. The current cribwall is about 20' under the slide zone. Additional comments on the movement: the borders of the slide zone on the left is flaking away fairly normally (in response to the oversteepening and removal of the toe), but the one on the right seems to border a fracture area. The border on the right is almost vertical and the two areas are moving independently.

During site preparation for the base of the cribwall, the heavy equipment operator removed a portion of the slope toe the night before. The fresh cut was left unsupported overnight and when excavation resumed the next morning, the slope moved. The slope was oversteepened in the adversely oriented bedrock causing failure of the bedrock and colluvial soils overlying the bedrock. In different material this might now have happened, and if the site had not been excavated and left exposed overnight, this slope movement might have been prevented. For future projects, on sites of this size and with propensity for large movement, however, it is recommended that a slope stability analysis be a part of project design.

Figure 21. Slope Failure

The research team recommended, and the PI approved construction could continue but with excavating no more than 10 to 15 feet of the slope toe at any one time. It was also recommended that exposure of personnel to the slope be avoided or minimized. Mike Whipple, Maintenance Area Superintendent, devised a plan to construct the log cribwall frames off site and to install them onsite in modules. No crew members were allowed behind or inside the cribwalls at any time.

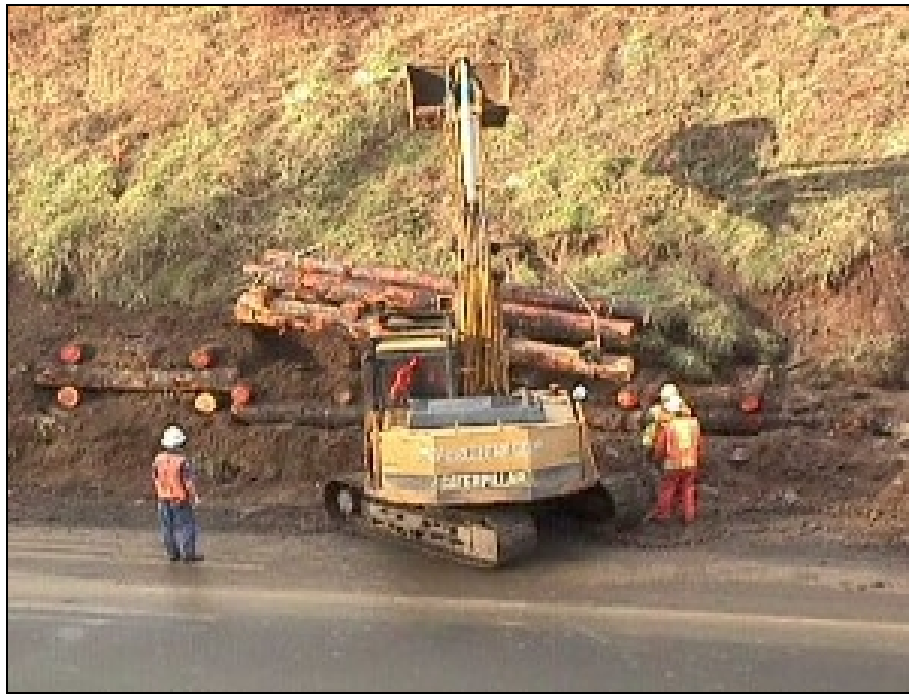
Figure 22. Installation of modular live cribwall sections

The modular cribwall frames were constructed off-site by February 28, 2000. They were installed in two vertical sections so willow branches could be installed between the lifts and soil could be added and compacted with the excavator bucket. Installation can be seen in Figure 22. Each 15 foot cribwall framed section was cabled to the adjacent unit and to the ones above and below it.

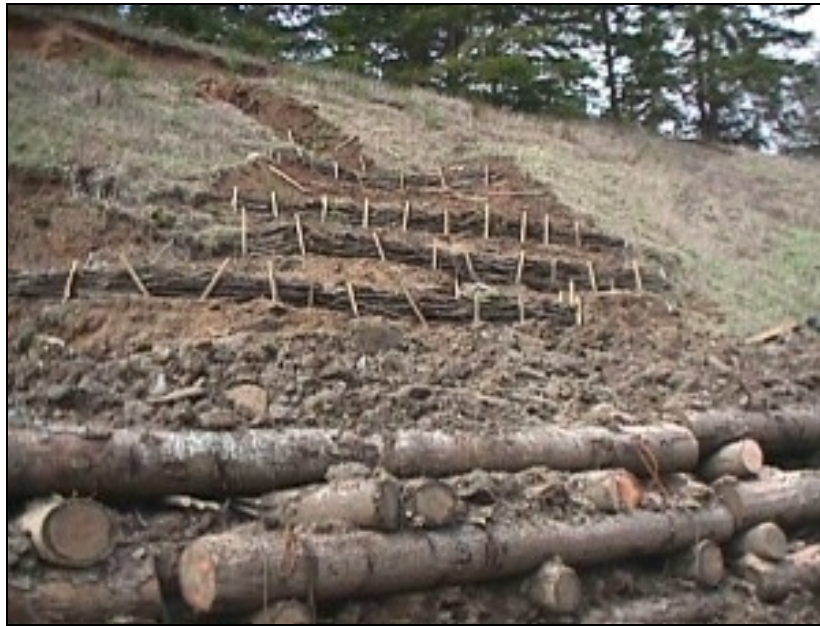
The live cribwall and cordon construction was completed with these changes, without incident, on March 2, 2000. The Crews finished the Raymond project, with willow wall construction further up the slope and with plantings and straw mulch application, on March 28, 2000. Figure 23 shows the willow walls constructed above the live cribwalls.

Figure 23. Live Cribwall and Willow Walls

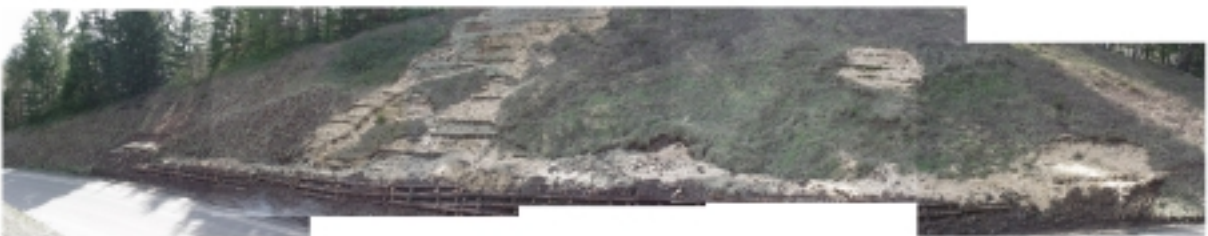
Figure 24 shows the entire project after completion.

Figure 24. Completed Soil Bioengineering Research Site
